**SAFETY AND PROTECTION FOR LARGE-SCALE
MAGNET SYSTEMS – FY91 REPORT**

R.J. Thome, B.A. Smith and A. Shajii

February 1992

Plasma Fusion Center
Massachusetts Institute of Technology
Cambridge, Massachusetts 02139

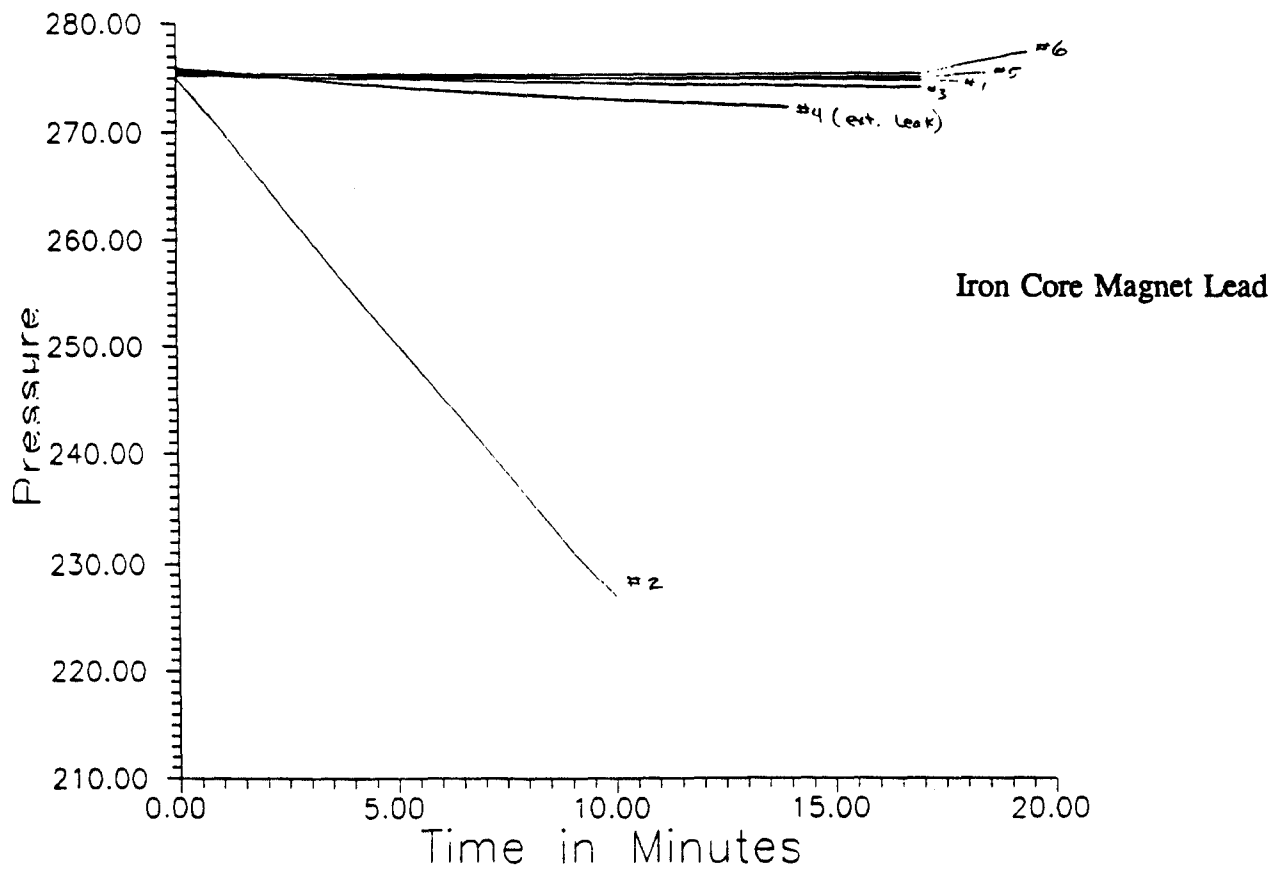
Figure 4 Hydrostatic N₂ Pressure Test in Double Pancakes 1-6
(courtesy MSE)

In order to locate the source of the water leak, each of the double pancakes of both East and West coil halves were hydrostatically tested using N₂ gas. Each double pancake was sealed after pressurization to about 275 psig, and pressure was monitored over time. The only significant leak found was in the number 2 pancake in the West coil, which showed a pressure loss rate of about 5 psi/min. Leak test results for the 6 double pancake windings of the West side coil are shown in Figure 4 (courtesy MSE). During the test on the number 2 double pancake, gas could be felt exiting from the inside vertical surface that faces the magnet iron in the end-turn region. Bubble solution sprayed over the end-turn surface also revealed a gas leak in the vicinity of the leads to the temperature switches which are mounted on double pancakes 2 and 3. Isolating the leak within the number 2 double pancake to one of the 90 water fittings was eventually achieved by a fill-to-a-level-and-pressurize routine and subsequently verified by borescope.

- 1) Hydraulically isolate and electrically jumper around the failed double pancake rather than attempt to seal the leak.
- 2) Create a new interlocking function based on an automatic over-temperature trip derived from a calculation of the temperature of each cooling circuit based on that circuit's electrical resistance. These resistances, and in turn, the temperatures, would be derived from the voltage tap and current measurements. In conjunction with this change, the voltage tap wiring should be rerun so each tap wire is twisted with each other in each magnet half, and only at the point of connection should the individual wire be separated from the twisted bundle. This will minimize inductive pickup during current ramping. This approach is recommended as an addition to, rather than in place of, the temperature

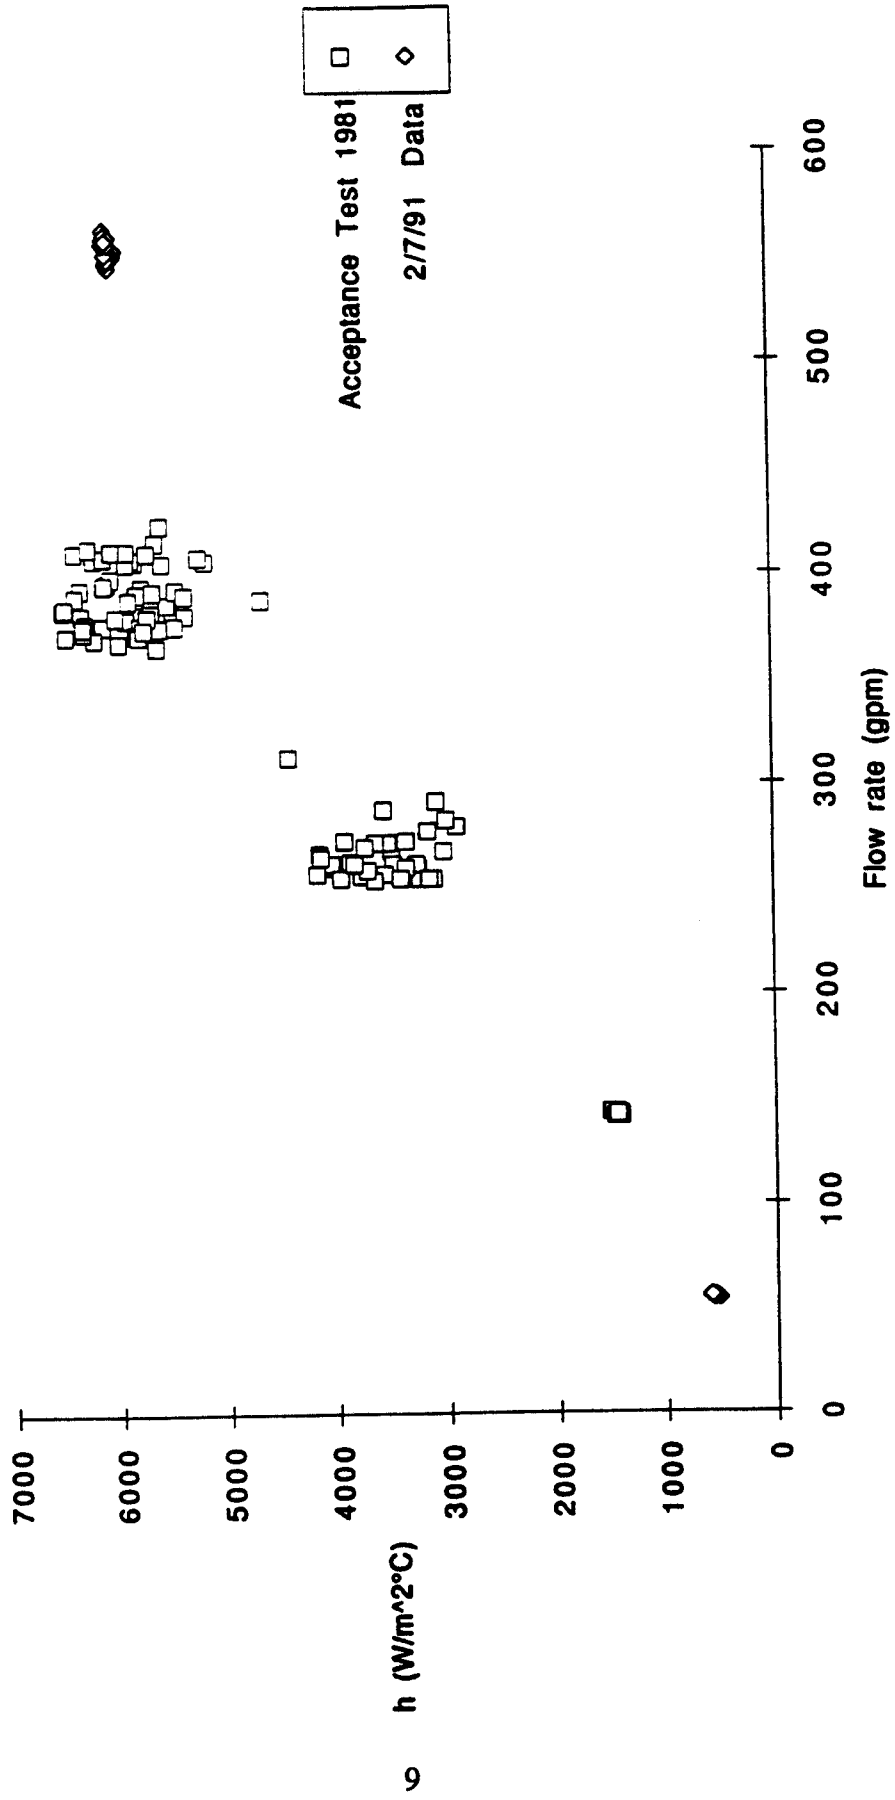
Figure 5 CDIF ICM Heat Transfer Coefficient vs. Flow Rate Comparison--Acceptance Test vs. Recent Data

Another item of interest was whether there had been any degradation of the heat transfer coefficient from the copper to the cooling water channel over time due to fouling of the wall. To evaluate this possibility, the derived heat transfer coefficient was plotted as a function of cooling water flow rate using data from the original acceptance test [4] and compared with data from a recent run on 2/7/91. This comparison is presented in Figure 5. The plotted data, together with transcriptions of the acceptance test and 2/7/91 data are tabulated in the accompanying tables. The data from the recent run on 2/7/91 shows heat transfer coefficient values outside the scatter band of the acceptance test data. The heat transfer coefficient in the recent data is still in the vicinity of $6000 \text{ W/m}^2 \text{ C}$ at full field, but about 550 gpm of cooling water flow are now required to maintain that heat transfer coefficient, whereas at the time of acceptance testing, only about 400 gpm were required to maintain the same heat transfer coefficient. Additional recent data in the 200-400 gpm range would be useful to fully assess the degradation.

The original design was based on a flow control requirement to maintain a constant average copper temperature. With this control approach, the magnet has maintained a constant operating temperature in spite of a degrading heat transfer coefficient. If, however, the heat transfer coefficient continues to degrade with time, some limit to the water pumping power will be reached unless measures are taken to clean the wall of the cooling channels.

- 9) Pursue cleanup of the cooling channel walls in an effort to restore the original heat transfer coefficient of about $6000 \text{ W/m}^2 \text{ C}$ at 400 gpm.

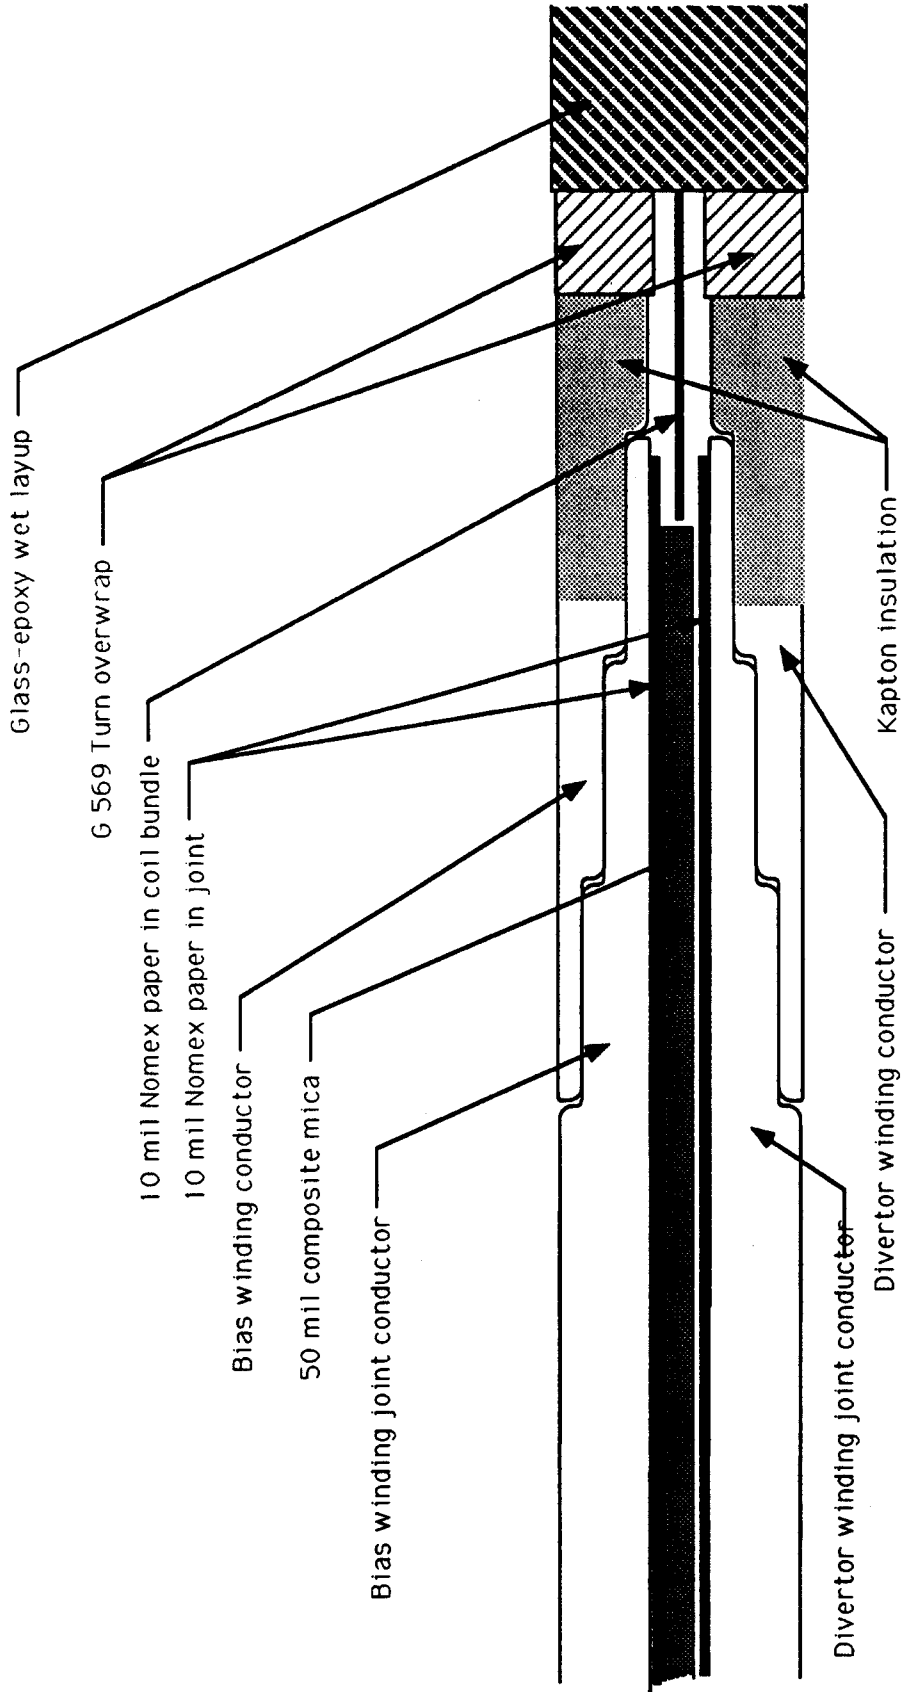
Figure 7 Insulation in Region of Failure

Figure 7 is a sketch of the finger joint region where the turns of the divertor and bias windings lie adjacent to each. It is the relative placement of the composite mica and the Nomex paper insulations during joint assembly that is both most critical and most difficult due to cramped working space and poor visibility.

During an increase of the plasma current from 150-175 kA to 200 kA, and while the divertor/bias windings were not energized, the plasma became very disruptive and the sound of the shots changed. Upon investigation, flashover was noted in the vicinity of the lower divertor-bias winding. Insulation in the failed region was burned away and the joint and coil fingers were coated with carbon/ash.

Photographs taken in the region of the flashover prior to joint disassembly showed what appeared to be about 1/2 inch of insulation overlap between the coil and joint Nomex paper insulations. This observation lead to two considered possibilities: 1) a metal chip or other foreign debris was present in the joint region which compromised the insulation integrity, and 2) the loop voltage may have been greater than the design value.

- 3) Since Nomex paper is noticeably porous, two 5-mil layers would be much better than one 10 mil layer in all locations.
- 4) If there is any slippage at the clamped joint, the possibility exists for making conductive dust in the region. The TEXT staff advised that the friction of the plated surfaces together with the clamping force were sufficient to ensure no slippage. This condition should be verified for disruption loads as well as normal operation.

- 8) Teflon spacers should be employed to preserve space for overlap of the joint Nomex cuffs on both sides of the Nomex paper in the coil bundle ends during epoxy cure.

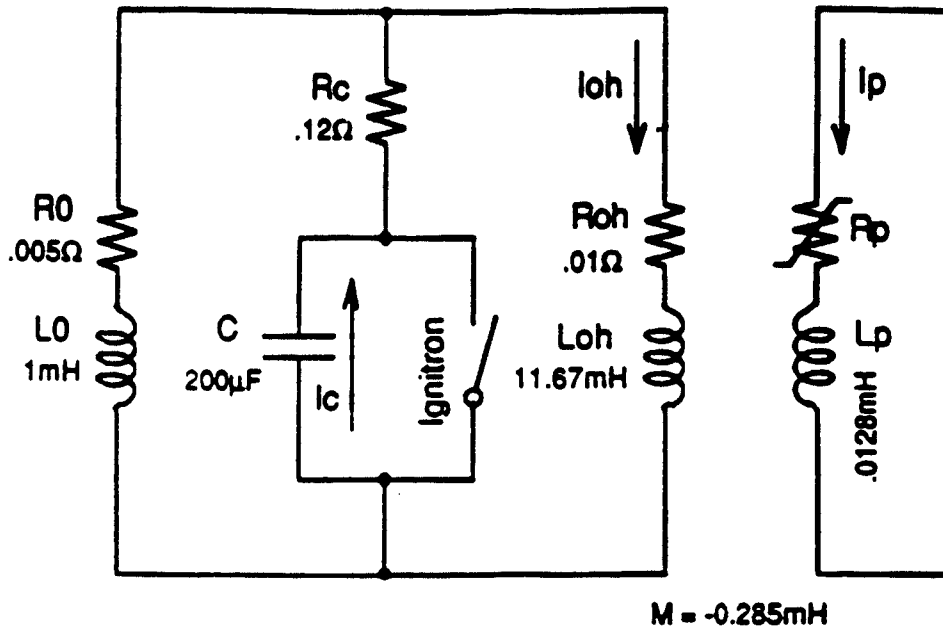
Figure 8 OH Protection Circuit and Parameters (courtesy TEXT Project)

To evaluate the loop voltage, a simple circuit analysis was performed on the circuit components shown in Figure 8 (i.e., no vacuum vessel and no other coil reactions). Assuming a plasma decay rate of 50 MA/s and a coupling coefficient of 0.8 between the plasma and the OH coil, the 40 turn OH coil voltage rises to about 77 V per turn in the first 8 microseconds, the time it takes the ignitron to fire. Then the OH voltage drops to about 60 V/turn immediately after the ignitron fires, and eventually decays to zero (assuming the OH source has, by then, been shut off). Thus, based on the simple analysis, it appears that there are indeed no fast voltage peaks and 85 volts appears to be a reasonable turn-to-turn maximum, provided the ignitron fires.

If the ignitron does not fire, circuit analysis indicates that the OH voltage can rise to a value in excess of 40 kV, with the first peak occurring at about 0.5 ms. The 40+ kV would put 1000 V/turn on the OH coil and 43 V/mil across the bias-to divertor winding insulation. This voltage stress would not break down the winding-to-winding insulation (if it were defect free), but would be sufficient to cause it to surface track if a surface tracking path existed. Whether

the voltage could ever reach 40 kV is questionable, as the 200 μ F capacitor would probably break down well below this level.

- 1) The ignitron firing reliability should be determined by testing under conditions which duplicate disruption as accurately as possible.
- 2) The output of the power supply used during the 1200 divertor shots should be checked for voltage spikes using a high frequency scope under similar conditions of inductive load and current level.

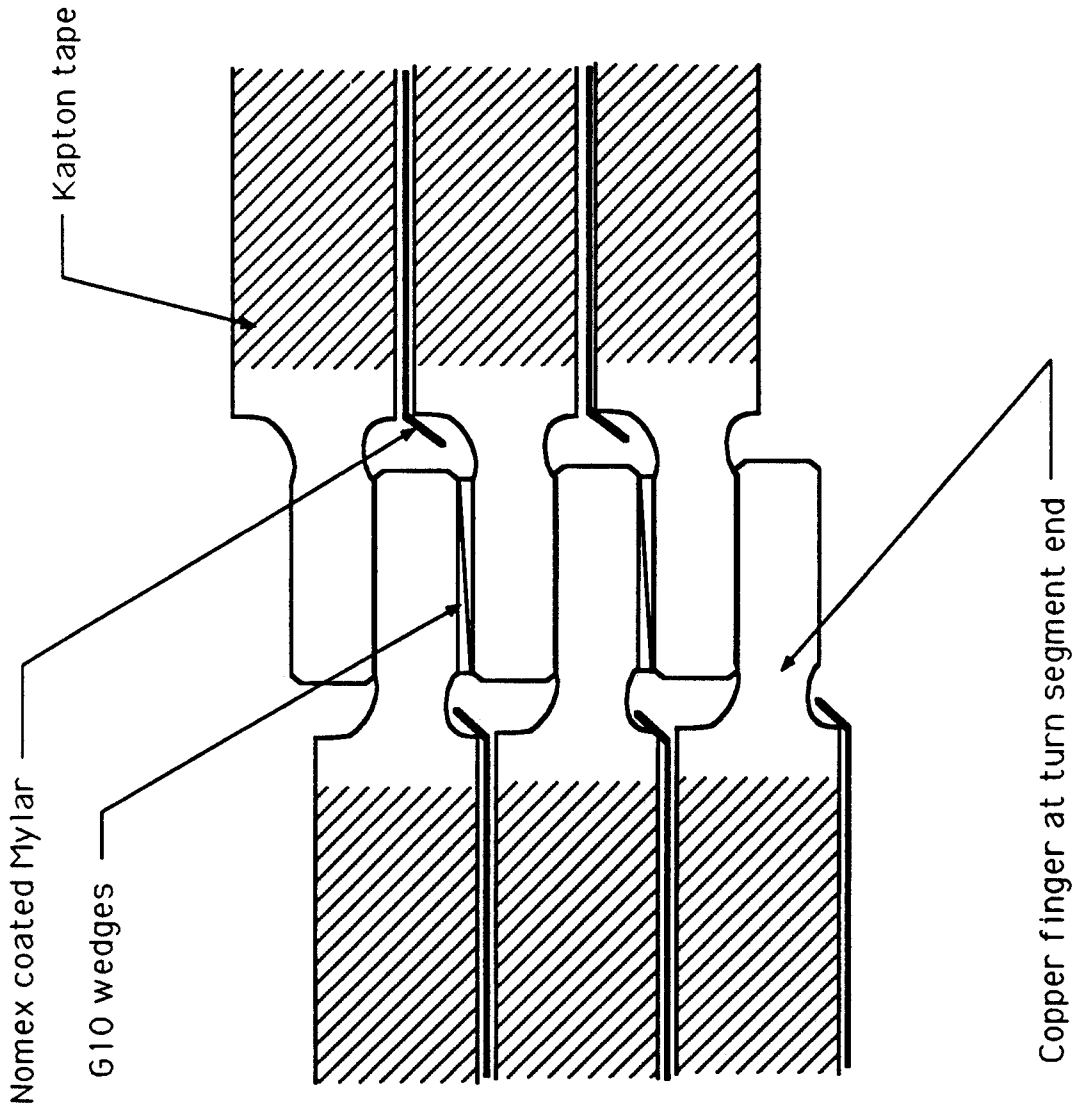
Figure 10 Three-joint Section of ATF Joint Region Showing Present Design

- 7) The exposure of bare copper in the joint region to the atmosphere (and water, dust, debris from nearby flashovers, etc.) makes it a likely failure region.

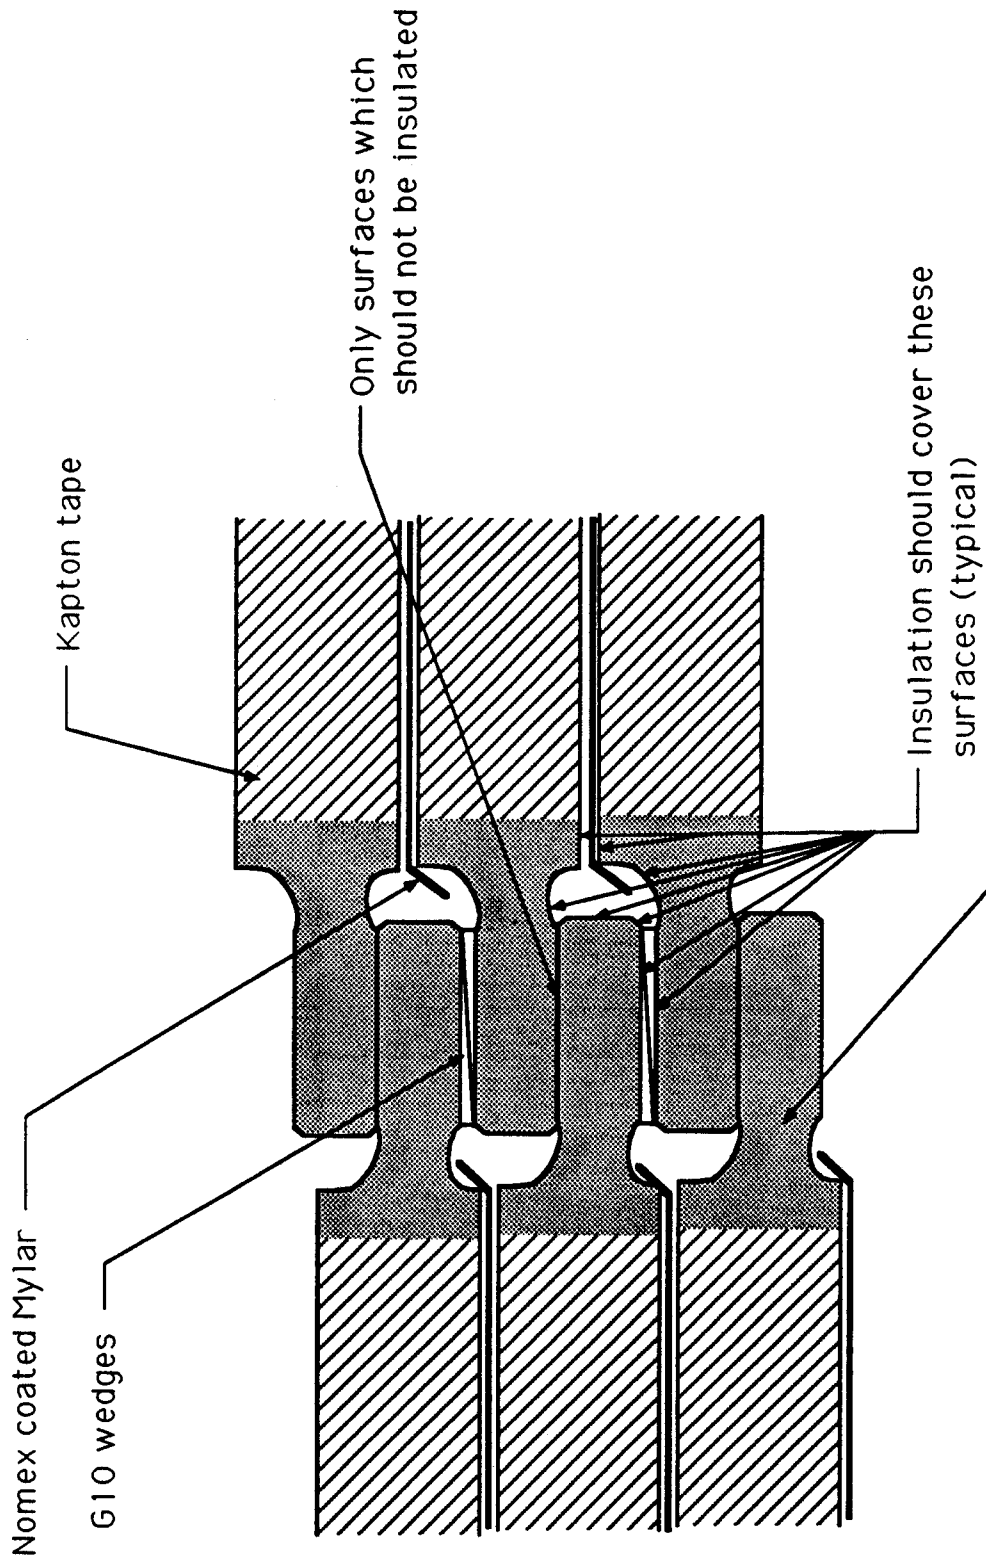
Figure 11 Three-joint Section of ATF Joint Region Showing Areas of Exposed Copper that Could be Insulated

Surfaces which are bare now and could be insulated (eg., by extending the Kapton tape, or using an insulating paint)

- 1) Establish routine preventive maintenance checks of the turn-to-turn insulation integrity.
- 2) Establish more effective drying routines following water spills or leaks.
- 3) Provide additional insulation on the exposed joint surfaces as shown in Figure 11.

The carbon-tracked joint regions were cleaned and an insulating, epoxy-based paint was applied to cover the exposed conductor surfaces as a temporary repair. This enabled a few additional shots at reduced duty cycle prior to beginning a complete machine disassembly, which is underway now.
