**SAFETY AND PROTECTION FOR LARGE-SCALE
MAGNET SYSTEMS – FY91 REPORT**

R.J. Thome, B.A. Smith and A. Shajii

February 1992

Plasma Fusion Center
Massachusetts Institute of Technology
Cambridge, Massachusetts 02139

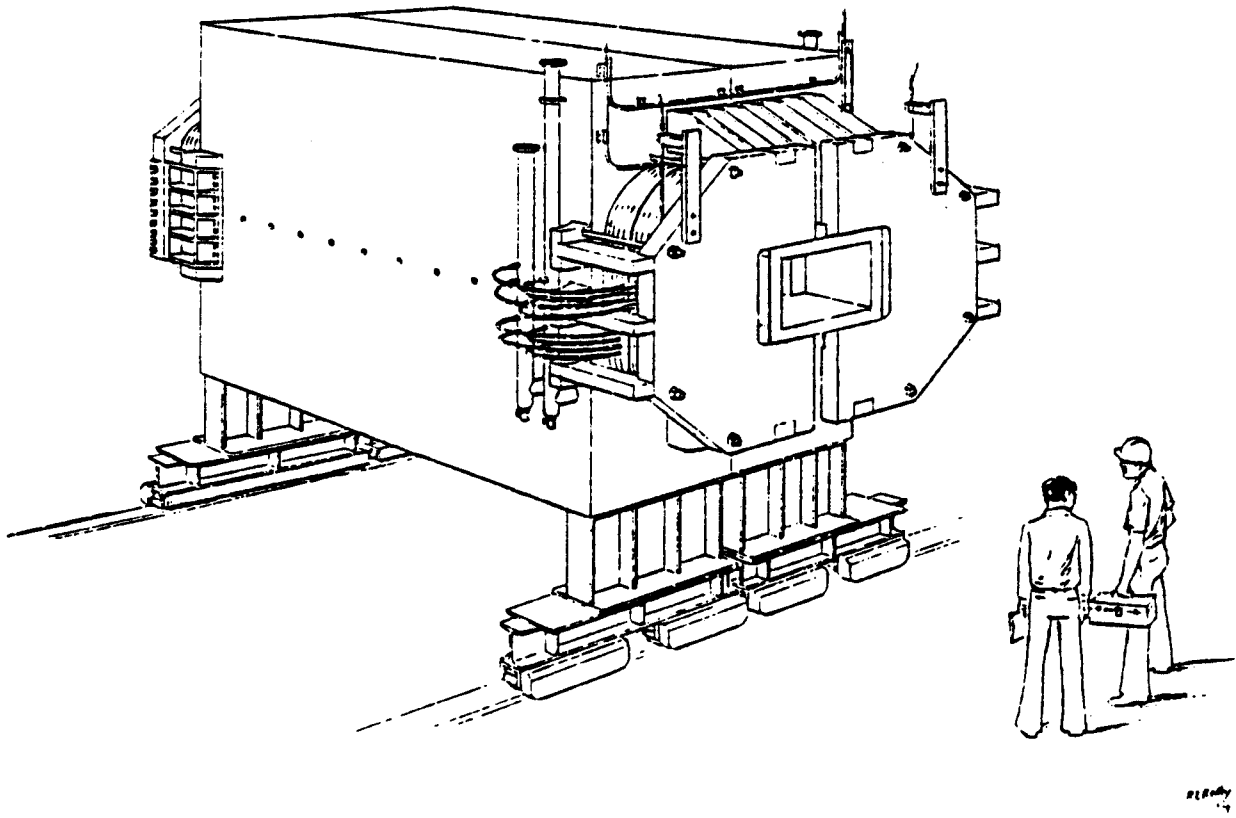
Figure 1 Artist's Drawing of CDIF Conventional Magnet (from Ref. 5)

The CDIF iron core magnet has water-cooled copper windings and a pole set and return frame made from carbon steel. The magnet assembly weighs approximately 170 tons. An artist's drawing of the magnet is shown in Figure 1. The magnet is built in symmetrical halves which part on rollers at the midplane to provide access to the MHD channel located in the magnet bore. A crossover bus bar connects the two magnet halves electrically. The magnet produces a peak field on the MHD channel axis of 3 T at a nominal operating current of about 8300 A. The saddle winding in each magnet half contains 144 turns in a 12 x 12 bundle arrangement, with 6 double pancake coils of 24 turns each. A cross section of the hollow copper conductor is shown in Figure 2. Separate feed and return manifolds provide flow through hoses and tubing to 52 individual water cooling paths per magnet half. Flow paths are two turns each in the outer (longer turn) region of the winding, and 3 turns each in the inner (shorter turn) region of the winding. Each cooling hose is connected to a copper tube which is brazed to a right angle fitting, as shown in Figure 3, in the MHD-outlet end-turn region of the saddles. The axially directed electromagnetic loads on each saddle end are reacted by a set of 8, 1-1/2" diameter, high strength, 1141 steel tie rods.

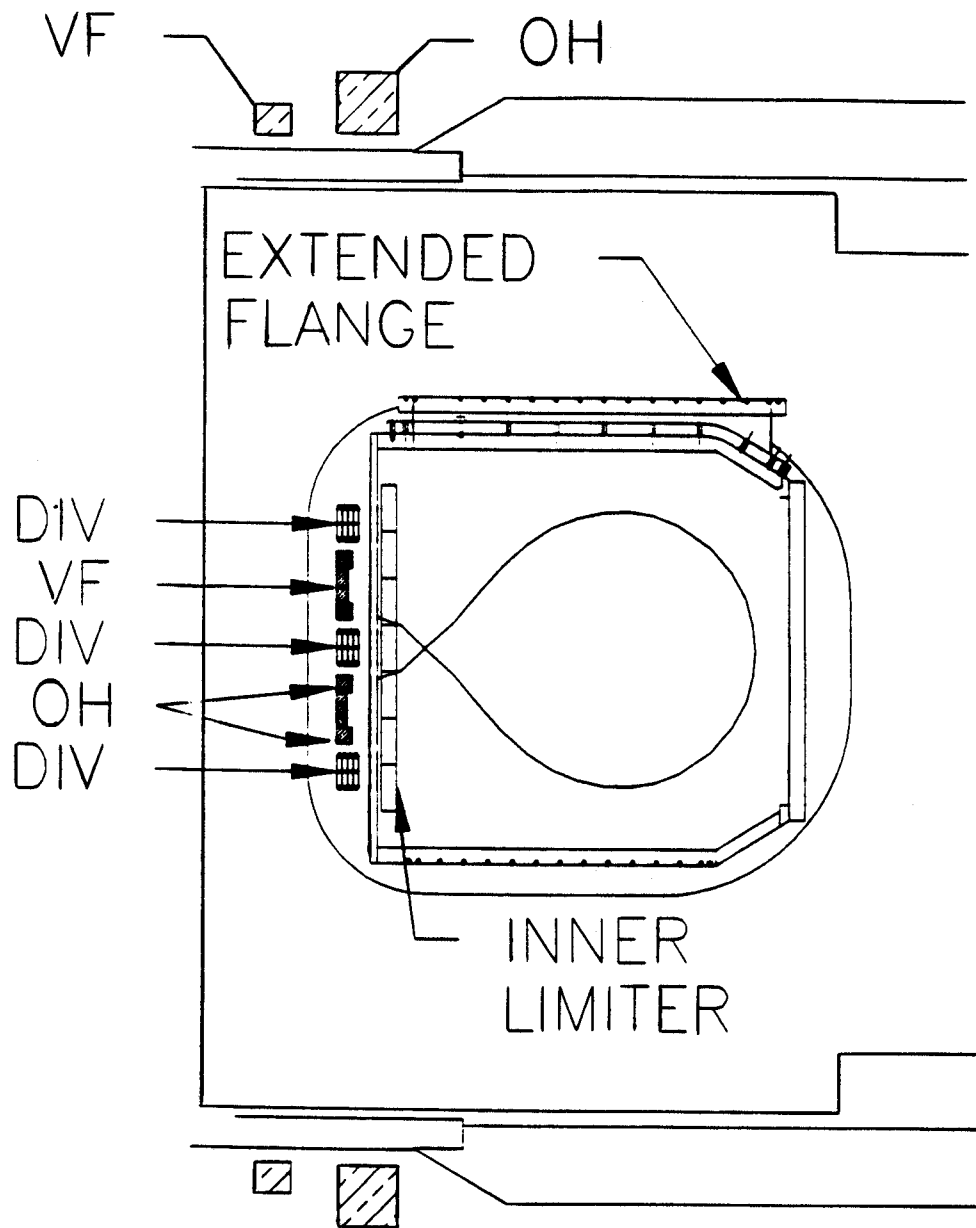
Figure 6 Partial Elevation View of Text Machine (courtesy TEXT Project)

The elevation view of the coil layout on the TEXT Tokamak is shown in Figure 6 (courtesy of TEXT). An iron frame returns the flux of the poloidal field coils. The poloidal coils consist of the Ohmic Heating (OH), Divertor (DIV) and Vertical Field (VF) coils, which are all wound as semicircular ring segments and are installed inside the bore of the TF coil. The coil conductor material is an alumina-dispersion-strengthened (ADS) copper (C157 series). The semicircular turn segments of the coils are joined by finger joints which are positioned, insulated and clamped together during machine assembly in rather tight working quarters. Visual inspection of the joints is made possible in some locations only by the use of small mirrors. The "divertor" winding bundle comprises four turns, in a 2×2 array, redundantly labeled the "divertor" winding, and four additional turns in another 2×2 array, labeled the "bias" winding. Under certain modes of operation, the divertor and bias windings are not energized, but voltages may nevertheless be induced in these windings in the presence of transient poloidal fields. Because of the manner in which the turns are wound and connected, the worst case voltage between the divertor and bias windings is three turn-to-turn voltages.

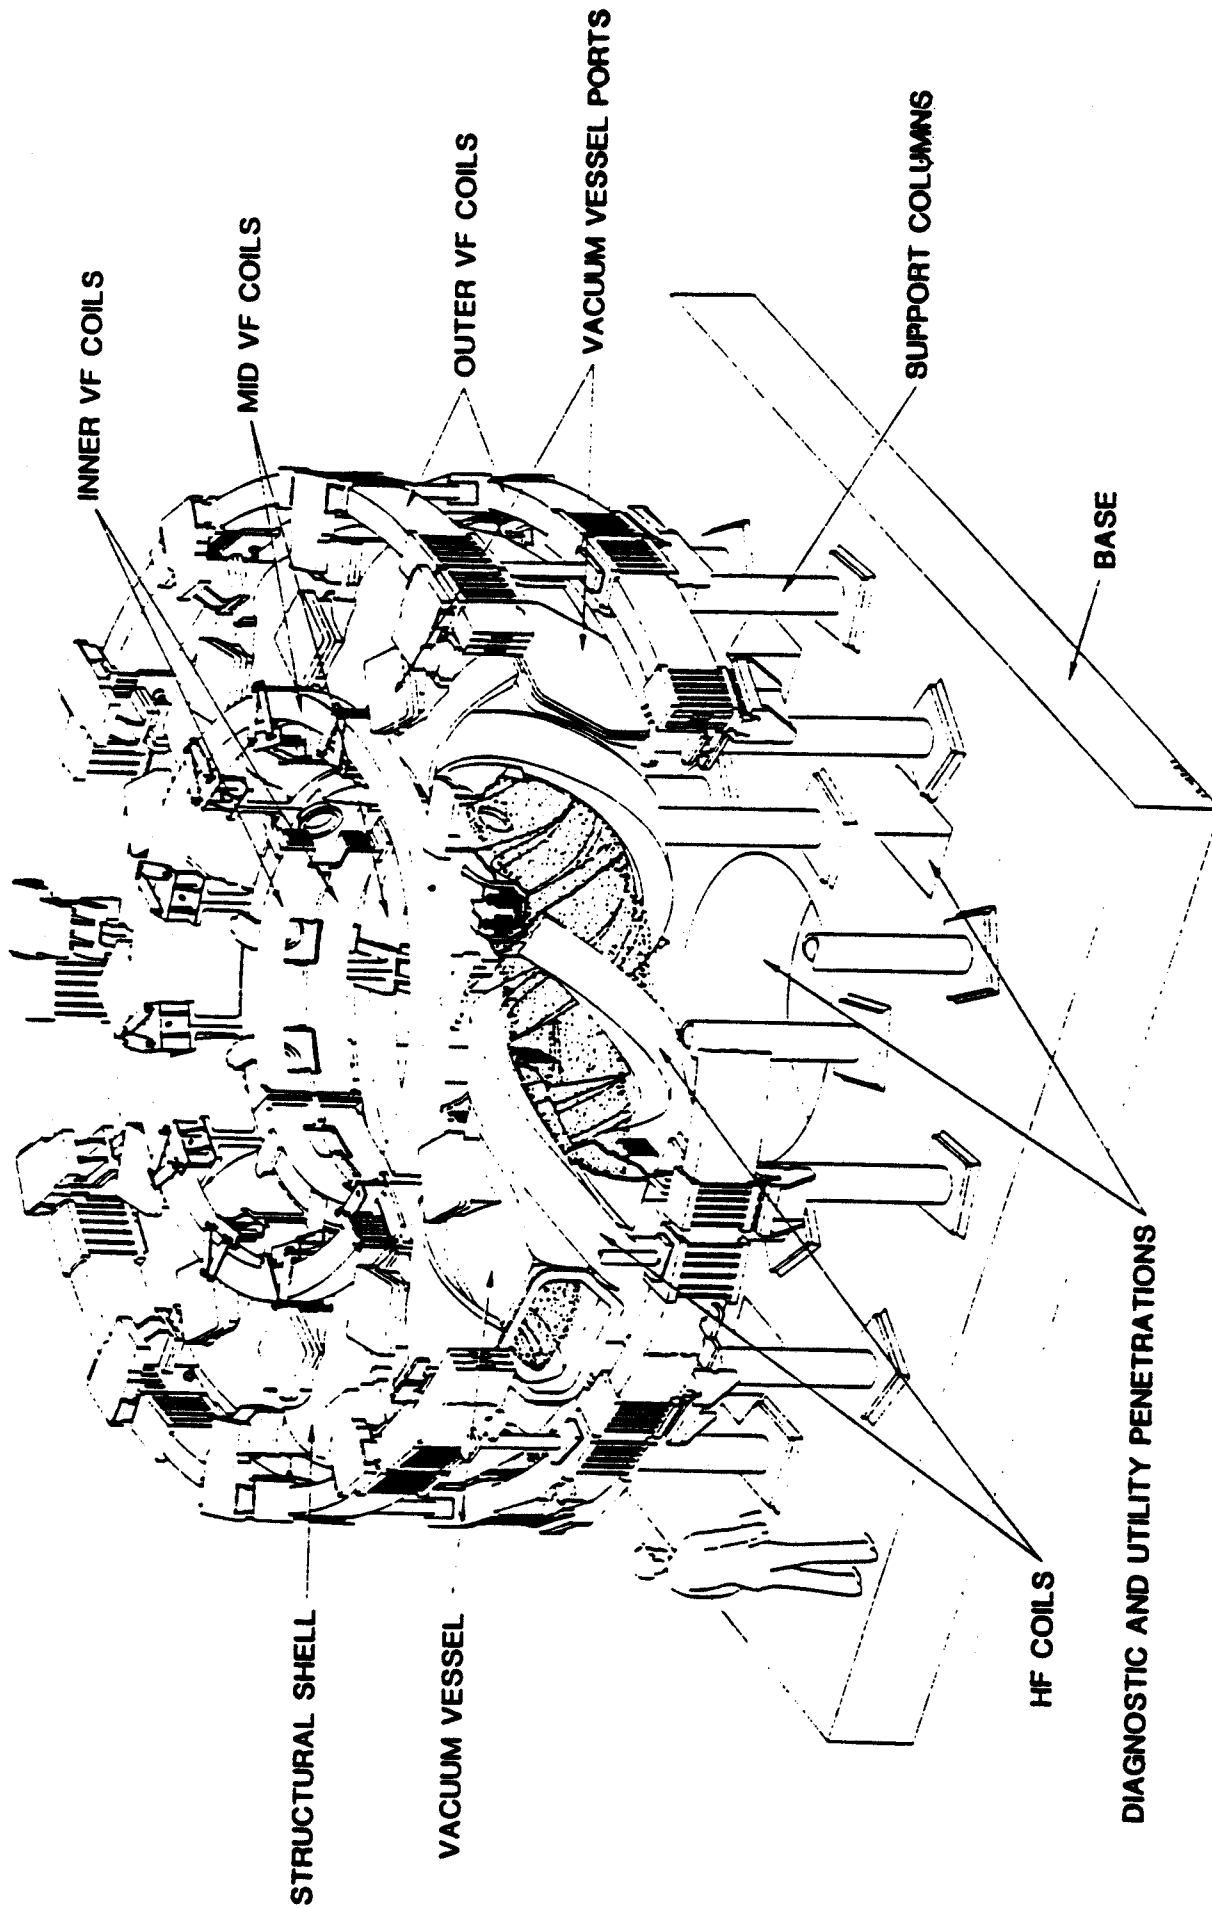
Figure 9 Advanced Toroidal Facility at ORNL (courtesy ATF Project)

The Advanced Toroidal Facility was constructed in the mid-to-late 1980's and is shown in Figure 9 (courtesy ORNL). The two intertwined helical field (HF) coils are fabricated from multiple identical copper segments which are electrically connected via clamped finger joints, three turns of which are shown schematically in Figure 10. Because of the open nature of the machine, the bare conductors in these joints are exposed directly to the atmosphere. The coils are designed to produce a full field of 2 T, although many physics shots have been conducted at the 1 T level. On full-field shots, the HF coils are ramped up to 120,000 A in 2 s with a power supply voltage of 1300 V. During the 1300 V ramping, the turn-to-turn voltage on the HF coils is nominally 325 V. The ramp-up timing is coordinated with powering the outer, followed by the inner vertical field coils.

Because there had been many previously successful shots at the full field level, the initial design appears to have been adequate, but during the time from the last successful shot at 2 T in March 1991 and the May incident, something had to have changed. In reviewing the operating history, the sequence of events and conditions identified below may be significant:

- 1) A set of error coils was installed 180° apart in March 1991. One of these was located above HF coil segment 17, where the failure occurred. Both of the error coils had experienced water leaks, the last one above segment 17 on March 20. The
